**Improve the Quality and Service Life of
Water-based Pavement Marking Paints on
Pavements with High-Iron Aggregates
Final Report**

Prepared by Jacobs Engineering Group Inc. for the
New Hampshire Department of Transportation in cooperation with the
U.S. Department of Transportation, Federal Highway Administration

1. Report No. FHWA-NH-RD-15680J	2. Government Accession No.	3. Recipient's Catalog No.	
4. Title and Subtitle Improve the Quality and Service Life of Water-based Pavement Marking Paints on Pavements with High-Iron Aggregates		5. Report Date August 2015

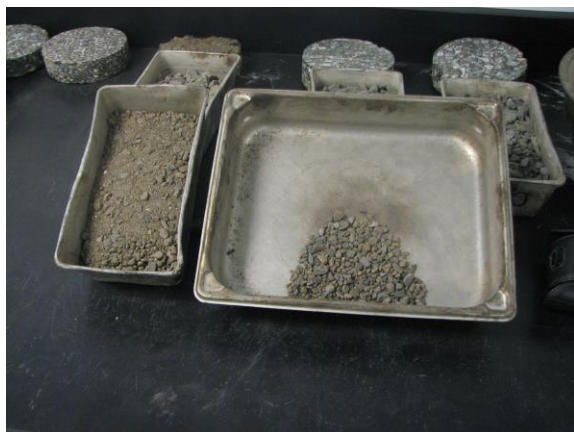
After the pavement cores were extracted, the NHDOT inserted a magnet into the sand size and smaller particles of the sample. The “magnet test” confirmed the presence of iron in the sand aggregate. Figure 4 shows the round pavement cores, the extracted magnetic aggregate. Further discussion of this testing is presented in Section III. The NHDOT laboratory testing results are provided in Appendix C.

Figure 4 - NHDOT Lab – Separated Magnetic Particles

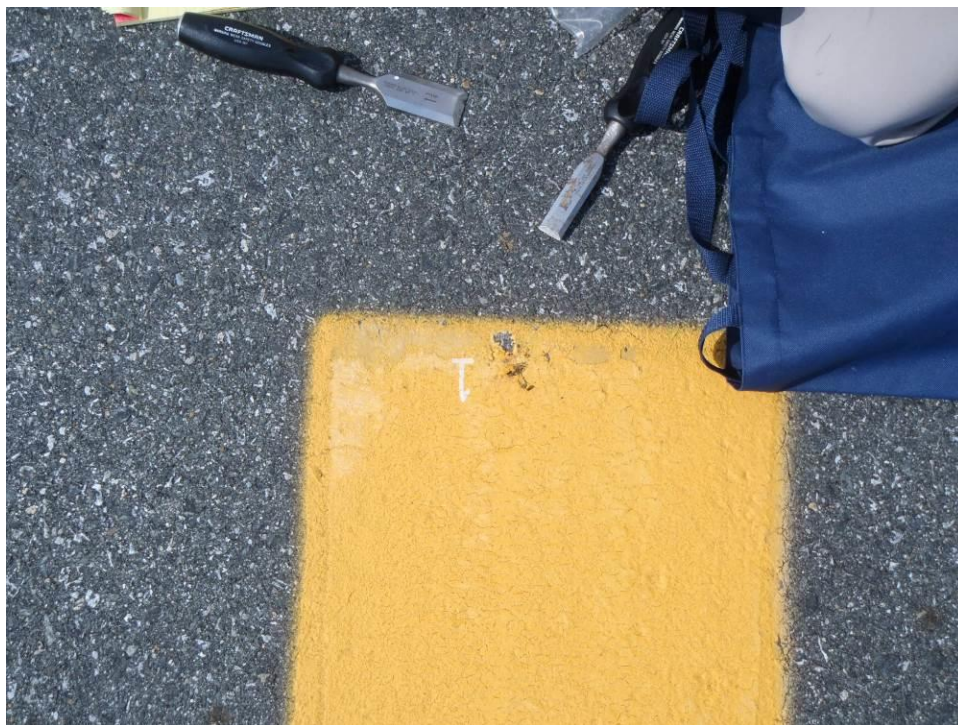
Photo 1 – Close up of paint sample 1. Note only the paint was removed.

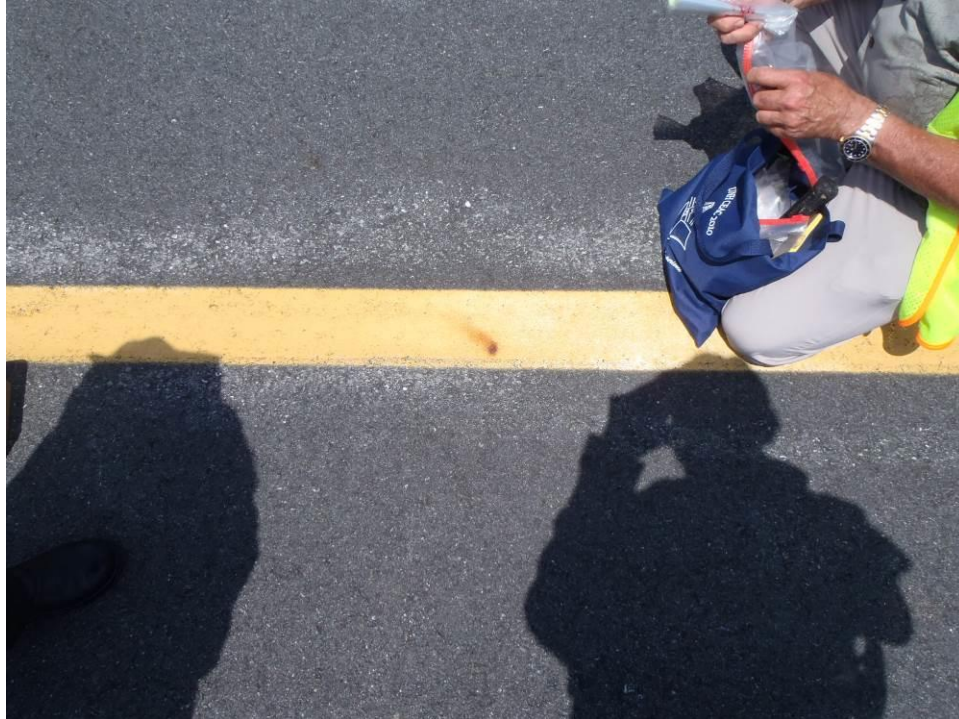
Photo 1 – Paint sample 1 taxiway C west about 200 feet west of taxiway A and C intersection.

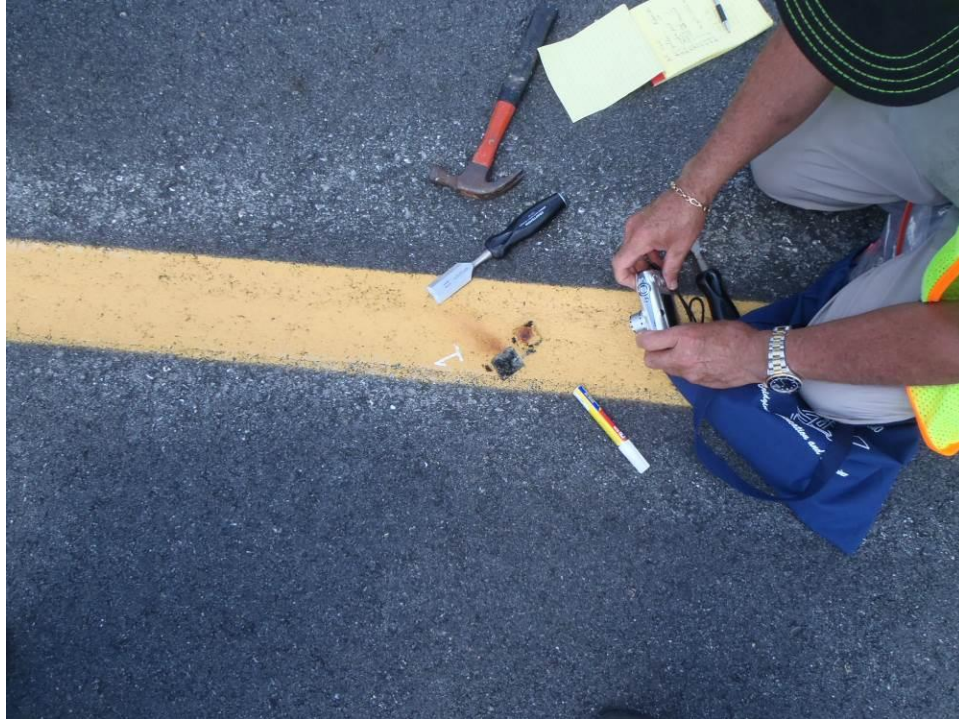
Photo 3 – Paint sample 1 after being removed.

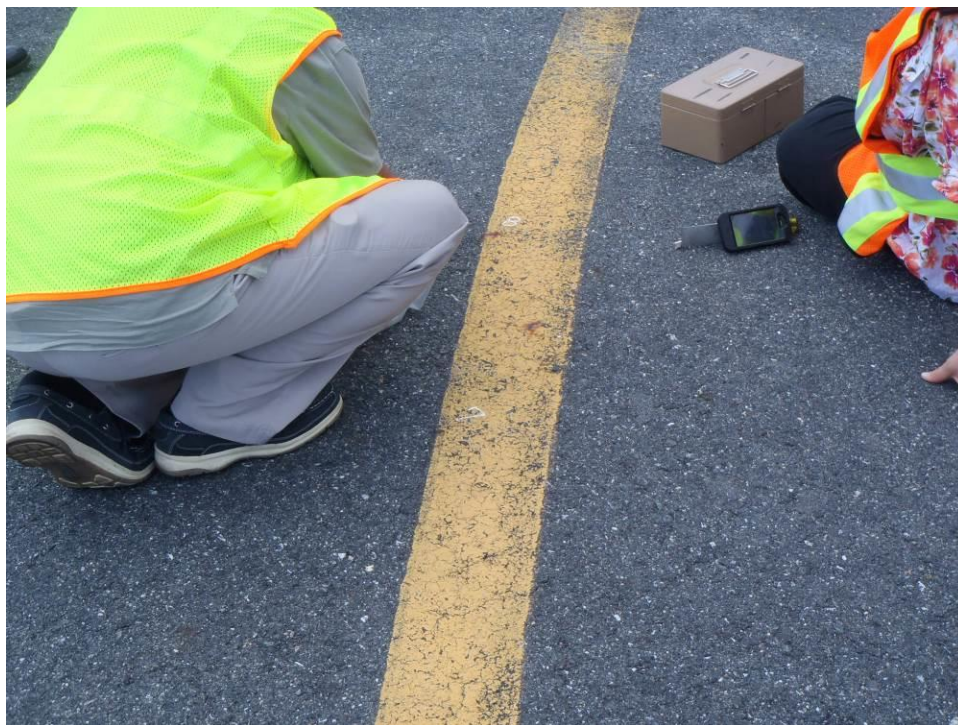
Photo 7 – Paint sample locations 7 and 8 west of core location 2.

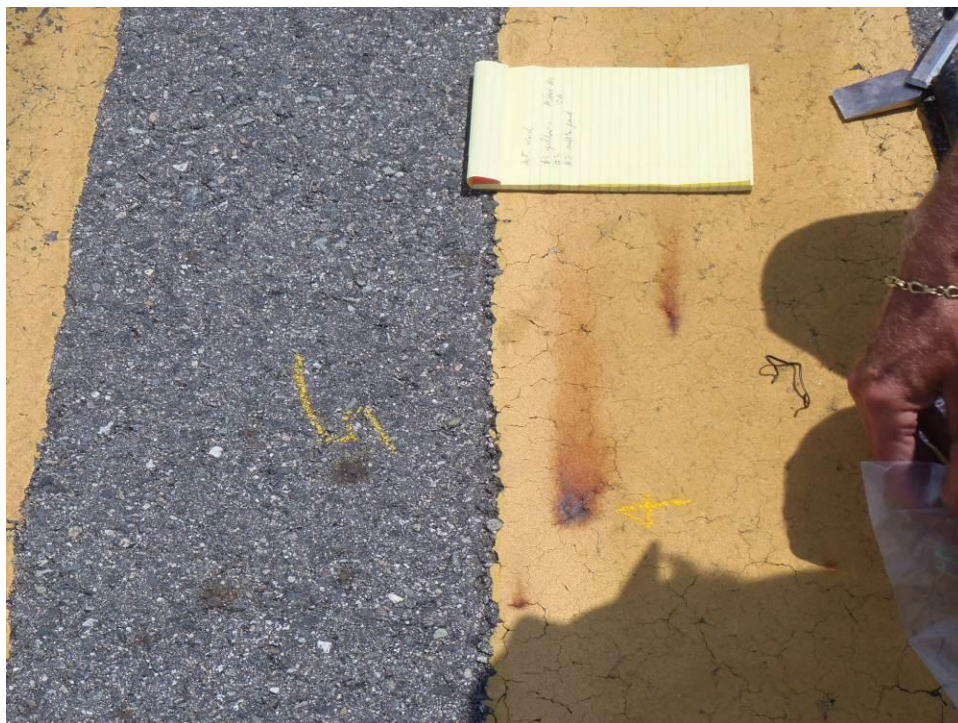
Photo 6 – Paint sample locations 4 & 5 western end of taxiway Hold Line

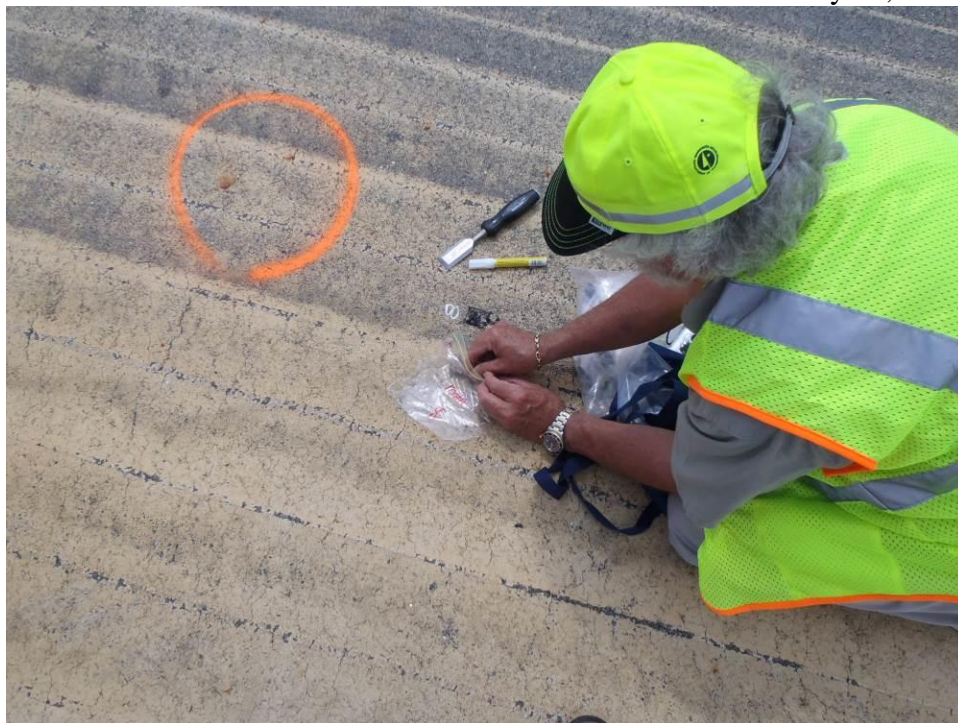
Photo 9 – Paint sample 8 located west of proposed core 3.

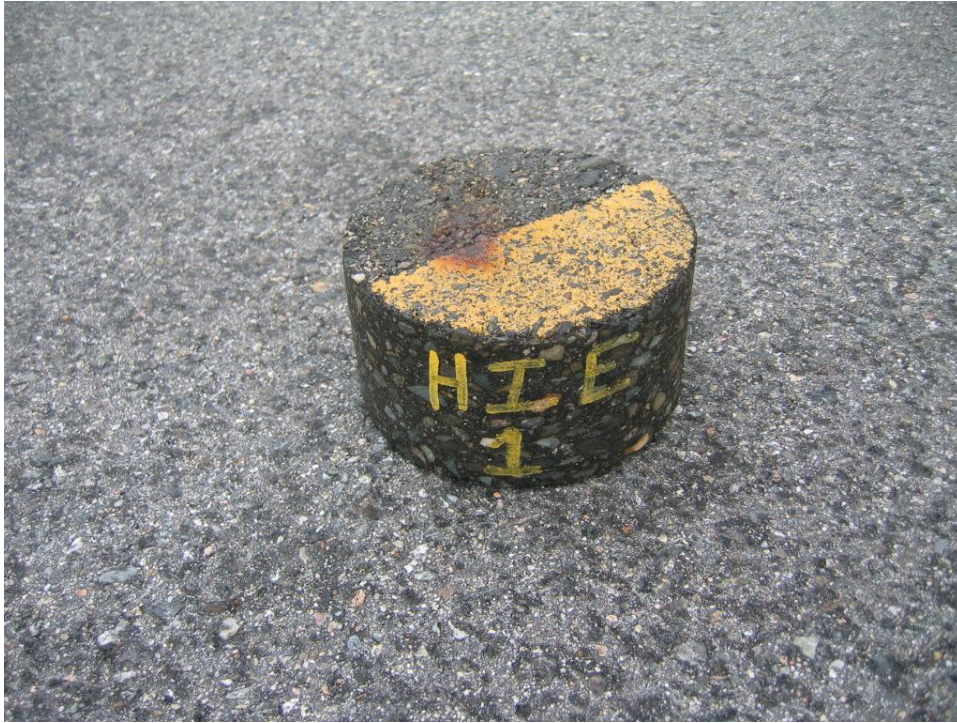
Photo 14 - Mount Washington Regional Airport (HIE) Core 1 from centerline of taxiway A near intersection with taxiway B

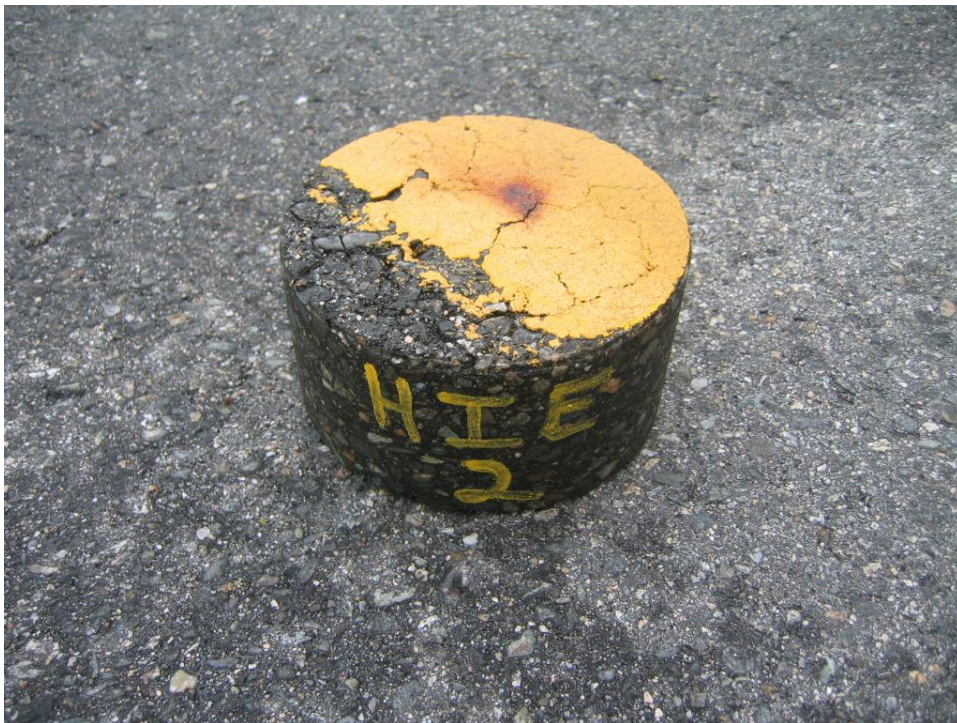
Photo 15 - HIE Core 2 from hold short marking taxiway A at runway 10 right side

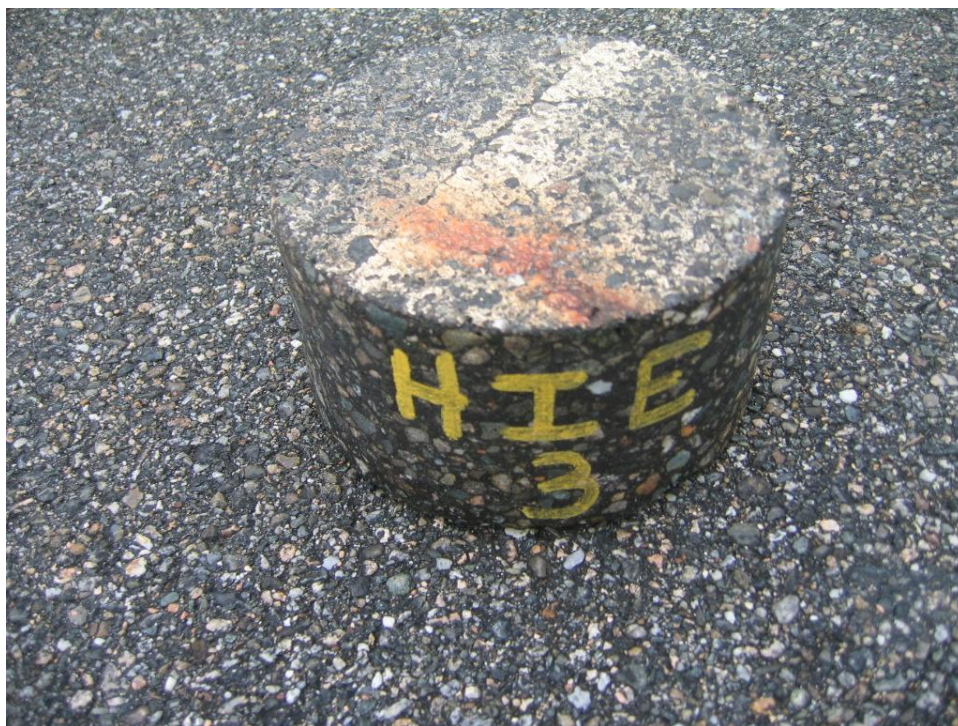
Photo 16 - HIE Core 3 from touch down marking runway 10 end left side.

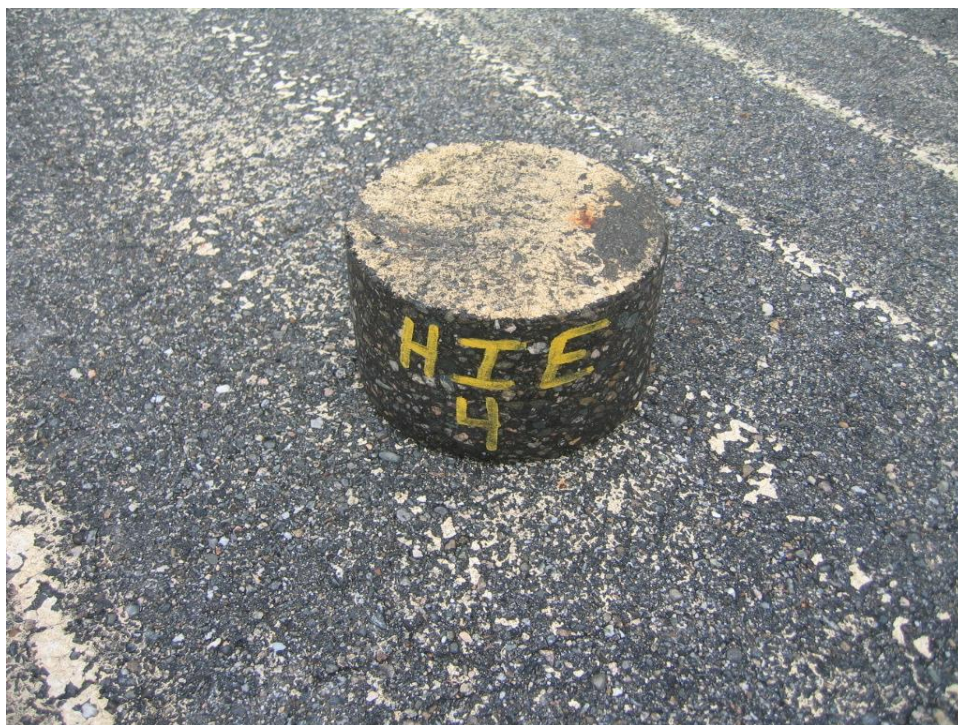
Photo 17 HIE Core 4 from touch down marking runway 10 end right side.

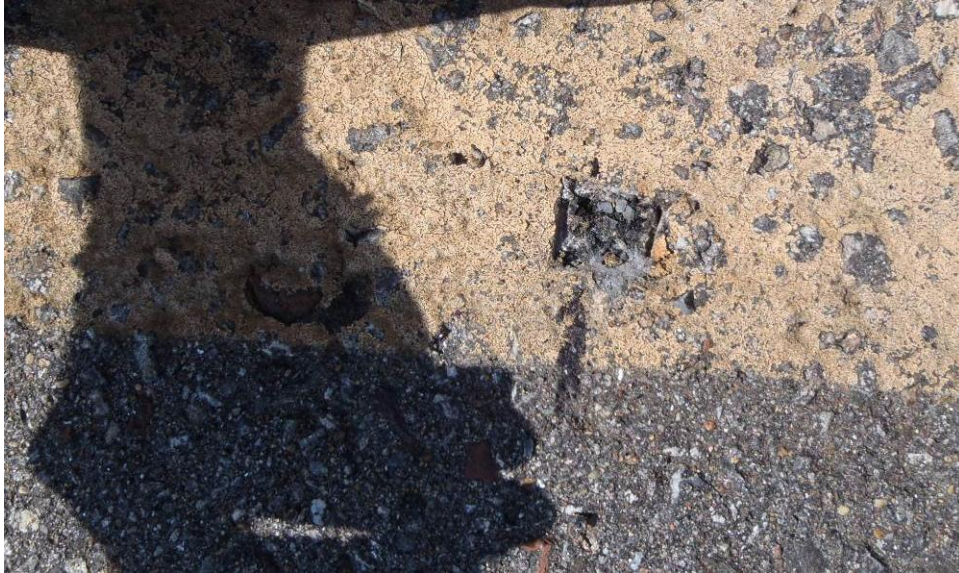
Photo 1 – Close up of sample 1 after sample was removed.

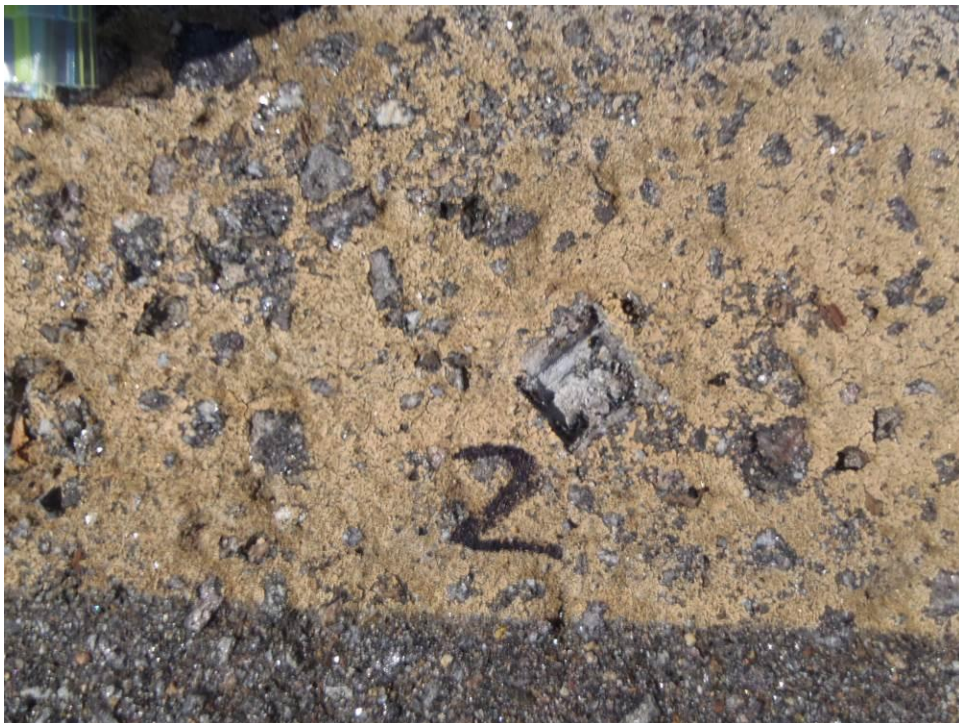
Photo 2 – Close up of sample 2 after sample was removed

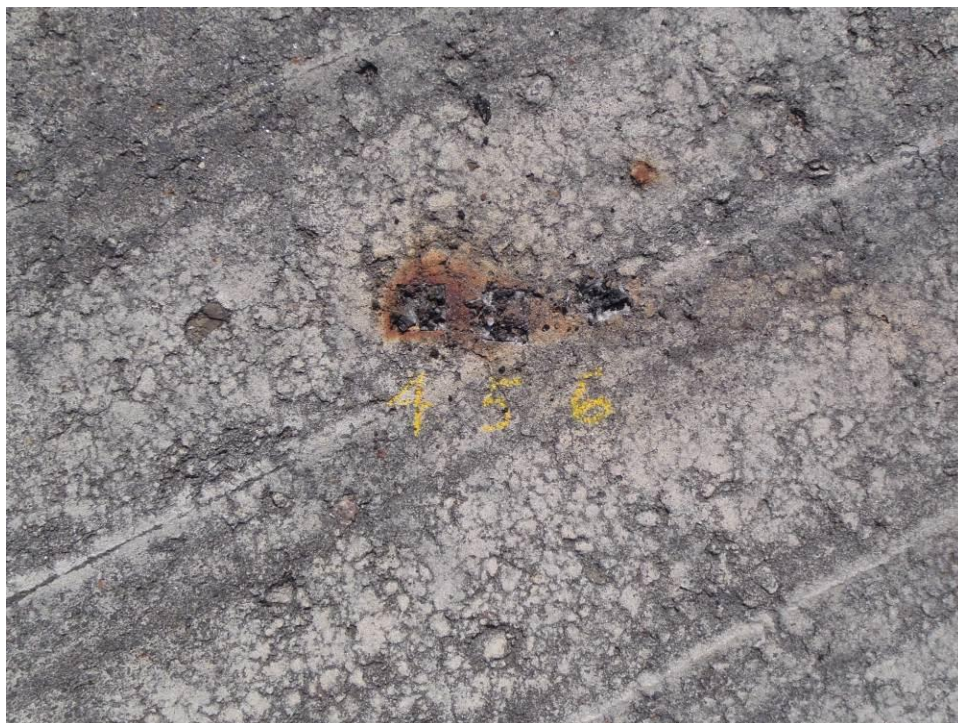
Photo 5 – Close up of paint sample locations 4, 5 and 6

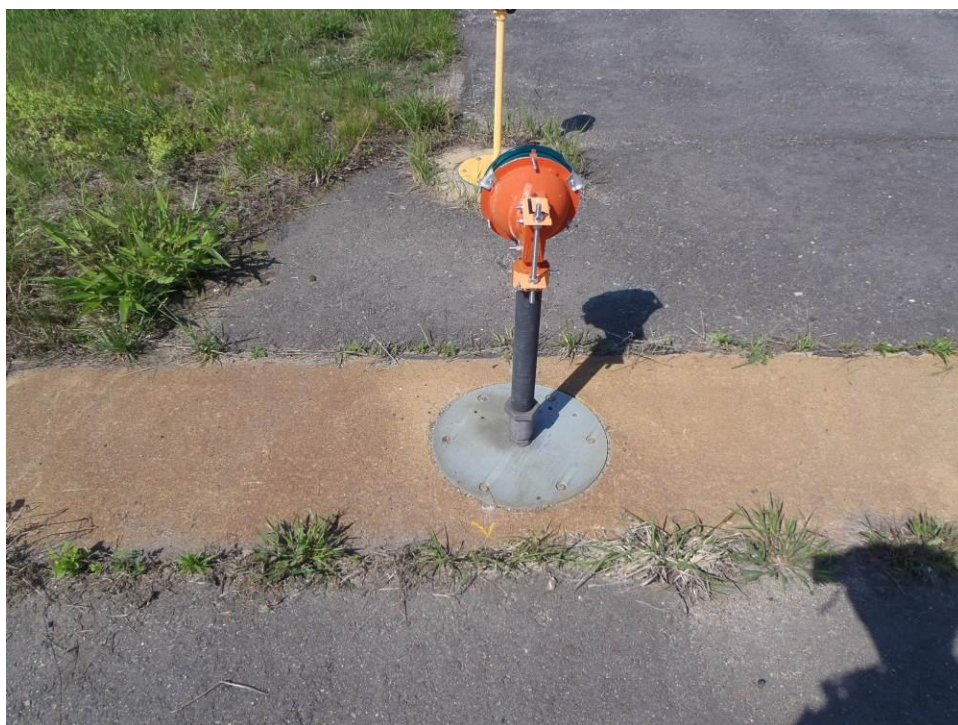
Photo 6 – Southern most runway end light Runway 8. Paint sample 7 taken at base of light.

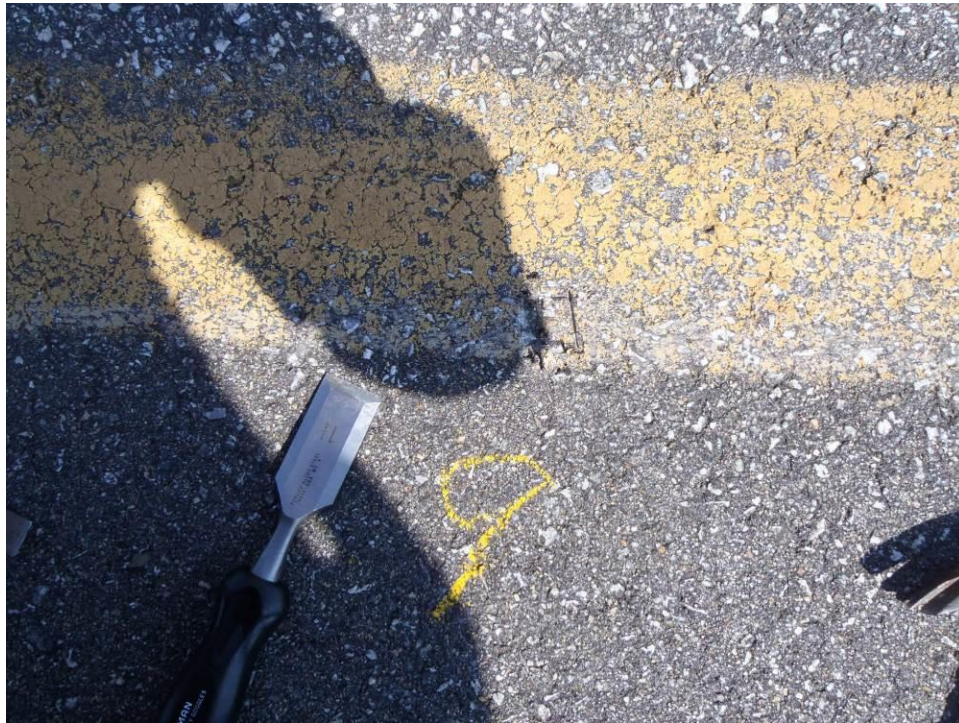
Photo 9 – Close up of paint sample 9 before removal.

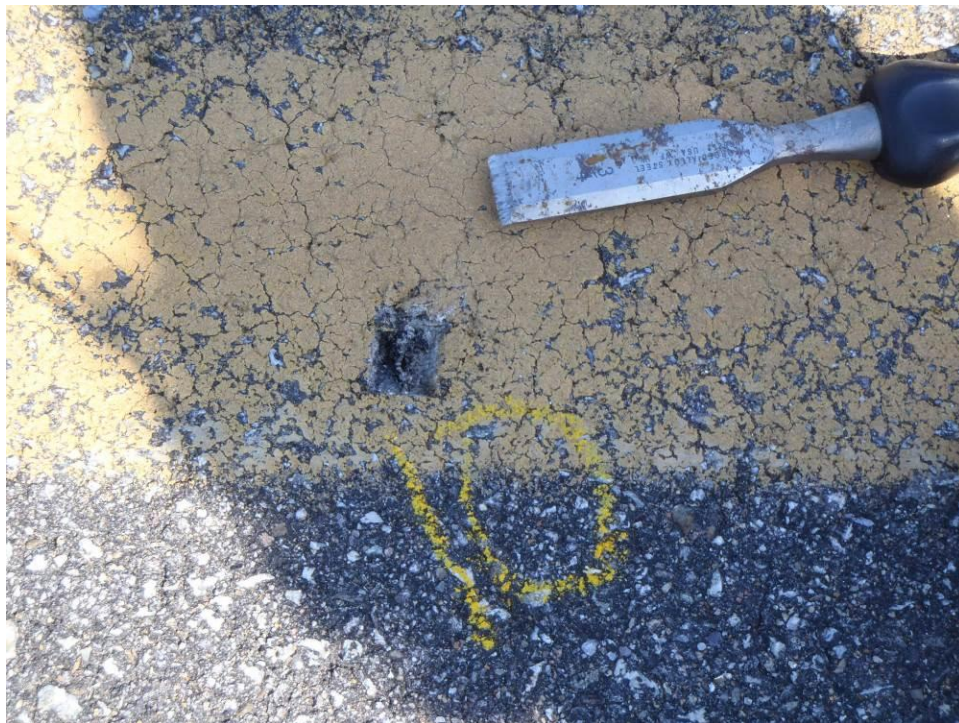
Photo 10 – Paint sample 10 after removal.

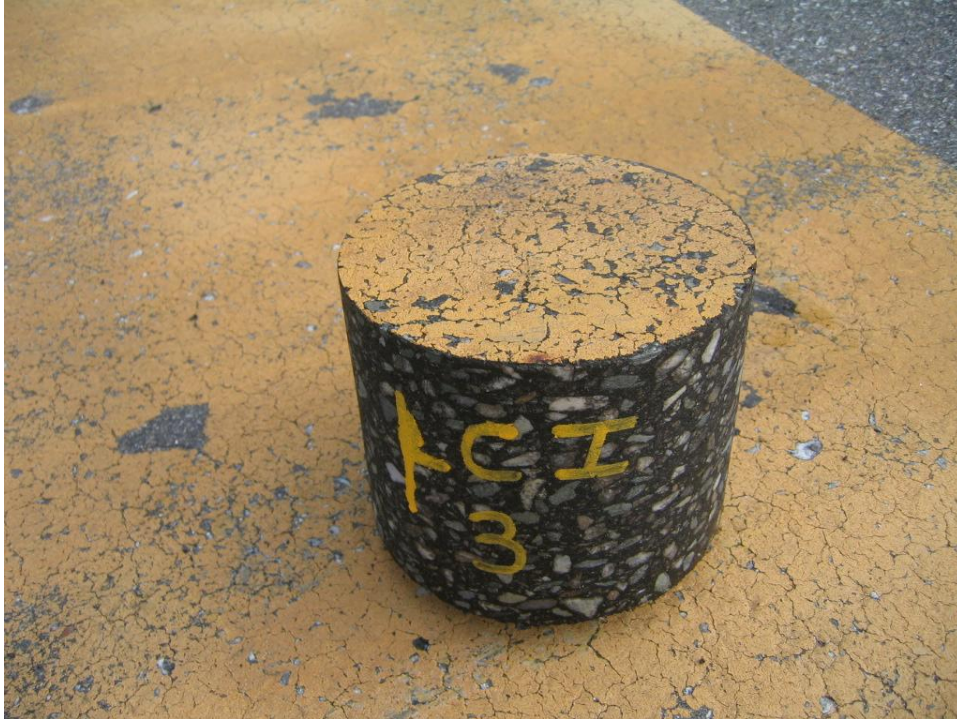
Photo 13 LCI Core 3 - taxiway C western end right side of ILS marking

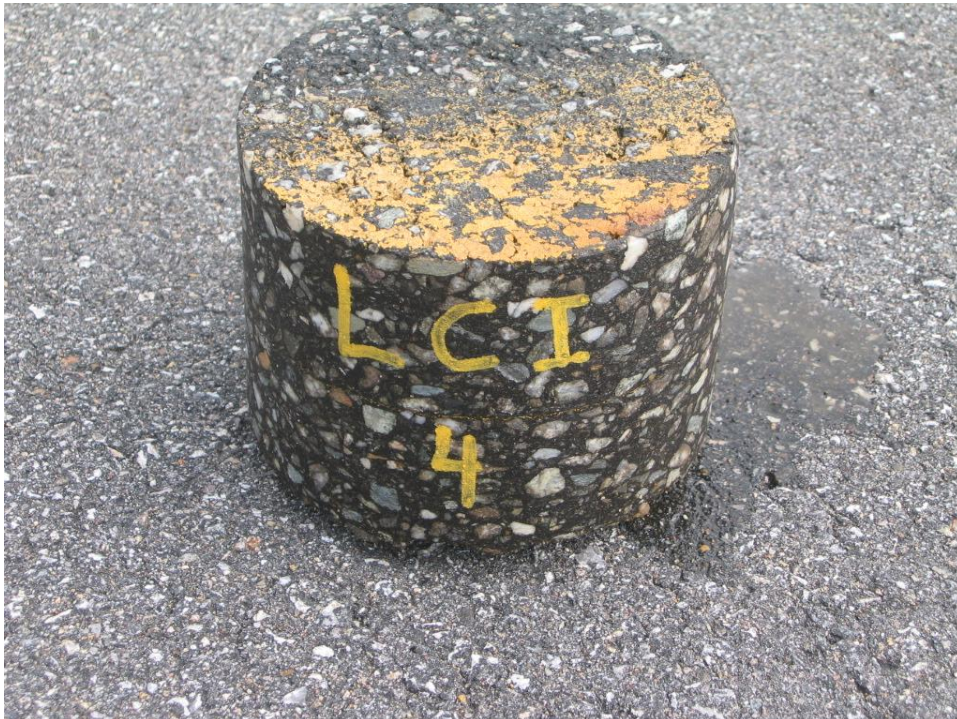
Photo 14 LCI Core 4 - taxiway C centerline across from terminal apron

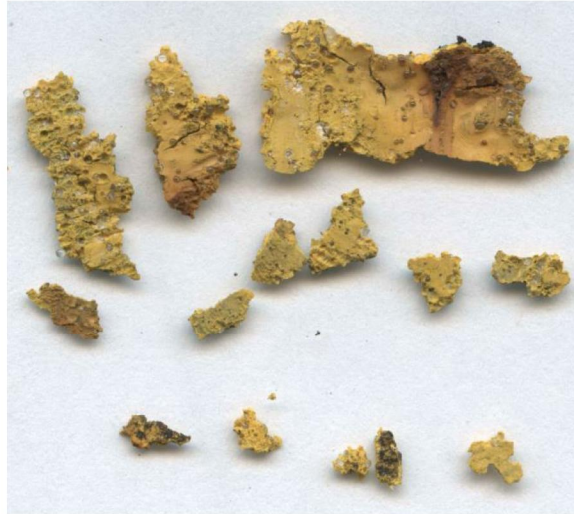
Figure 11 Keene paint chips

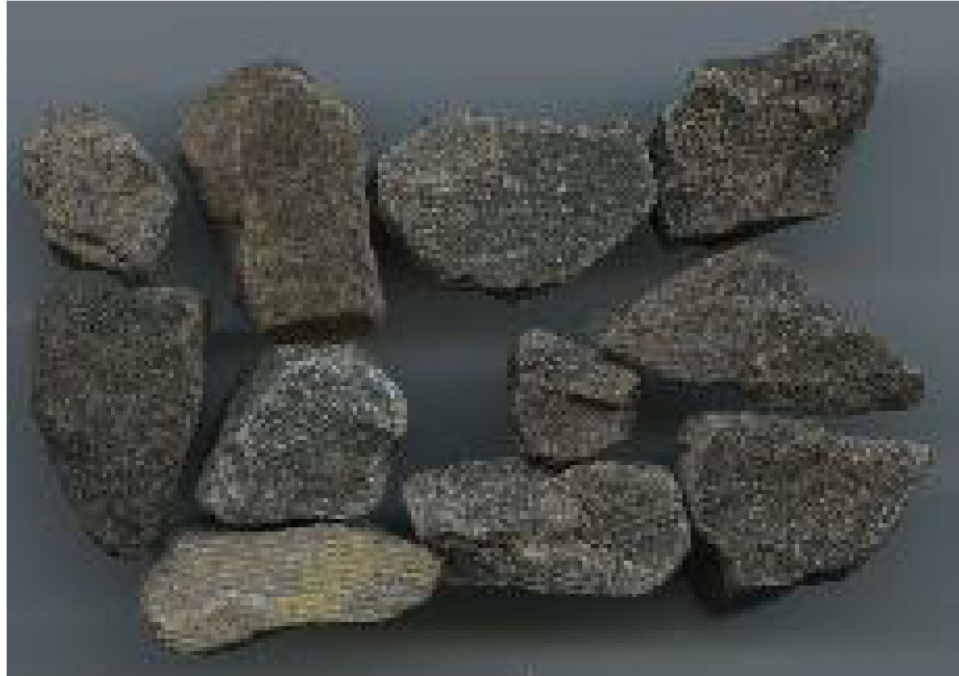
Figure 81 Concord magnetic aggregates

A group of the coarse size magnetic aggregates from each airport were compiled from the extracted from the cores. Figure 81 shows the ½" magnetic aggregates from Concord. The Claremont ½" magnetic aggregates are shown on Figure 82. Keene, Laconia, and Whitefield ½" magnetic aggregates are shown on Figures 83 through 85 respectively. Color, texture, visual crystallinity, grain size and shape were used to select unique aggregates for petrographic analysis. The rocks in general were variable so to make sure all possible minerals were included a total 38 different aggregate particles were selected for petrographic analysis. A selection of aggregates from each source based on visual differences discussed above included twelve from Claremont, five from Concord and fifteen from Whitefield. None were selected from Laconia for two

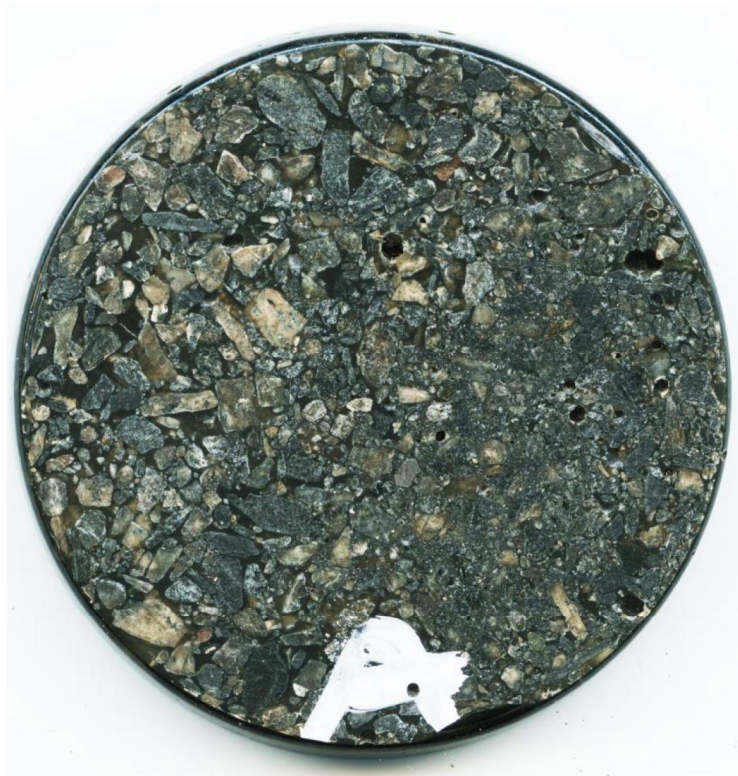
Figure 86 Claremont magnetic aggregate epoxy disk side A after polished in ethanol alcohol

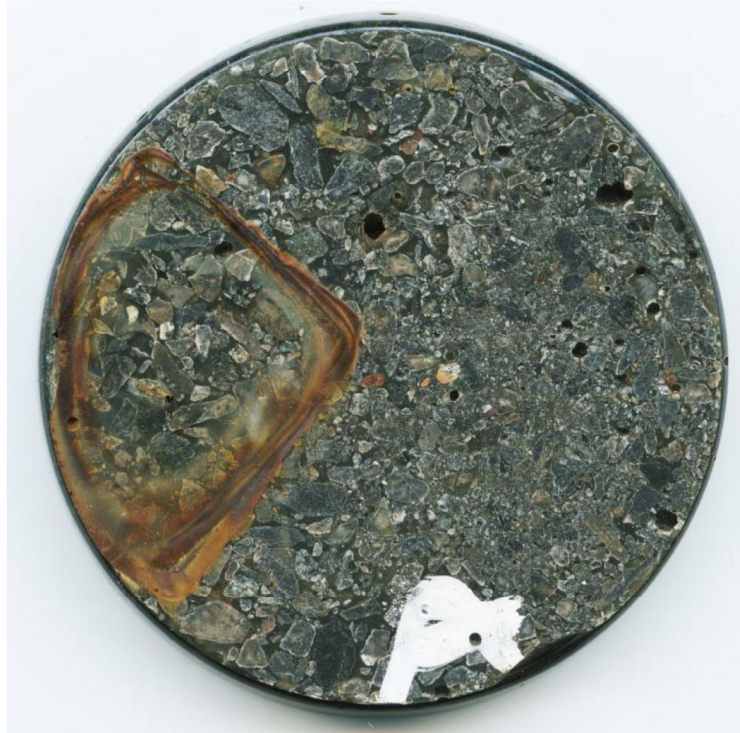
Figure 87 shows Claremont disks sides B and D placed on 1"x1"x1/4" stainless plate such that the disks were above the water line and subject to humidity only. The containers were placed in an oven held at 100 °F for 3 months. Figure 88 shows disk B/A after 3 months of storage over water held at 100 °F. It was noted that rust staining occurred on the plastic container where the stainless steel plate had been. The bottom side of the B face (side A) also showed rust where it had been placed on the stainless steel plate as shown on Figure 89. In all cases the stainless steel showed no signs of rust. The rust originates in the aggregate then becomes mobile and deposits elsewhere similar to what happens in the field on the paint markings and the HMA surface. A close up of the before and after soaked for 3 months is shown on Figure 90.

Figure 89 Claremont magnetic aggregate epoxy disk side A after soaked over water at 100 °F for 3 months
